Manhole Inspection Summary

Manhole # S41WW_019MH

Location Address: **1303 GORSUCH AVE**

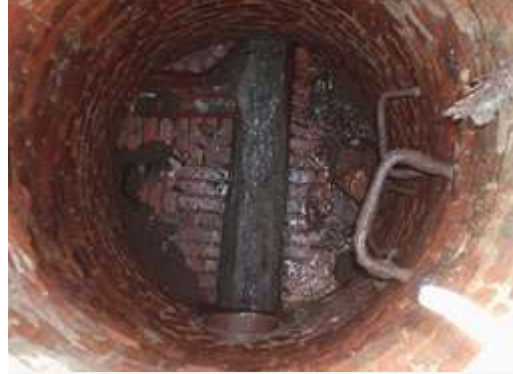
Top View

Adjustment and Corbel infiltration.
Corroded and missing steps. Bench and
Channel debris.

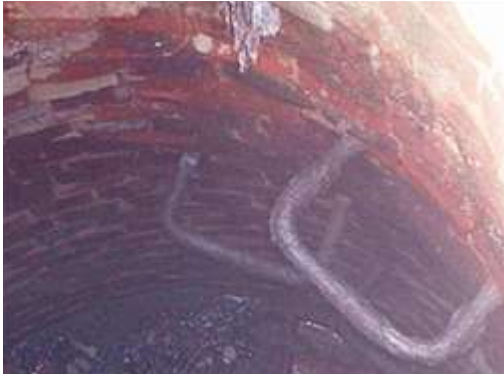
Defect

Corbel infiltration. Corroded and missing
steps.

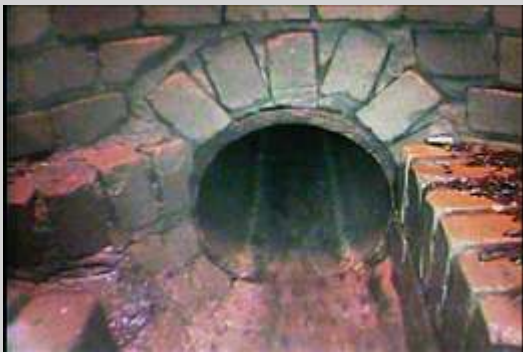
10 in. Circular Gravity Sewer Pipe Out @ 12 O'Clock

Infiltration: **Evidence** Pipe Seal Cond: **Unknown**

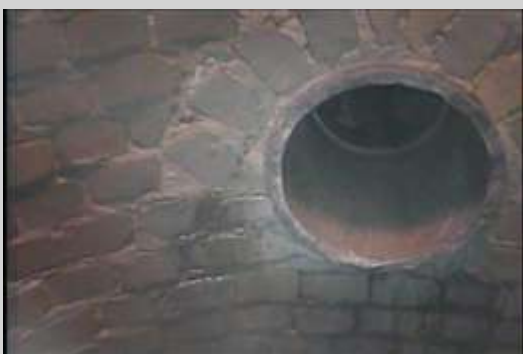
10 in. Circular Gravity Sewer Pipe In @ 6 O'Clock

Infiltration: **Evidence** Pipe Seal Cond: **Cracked**

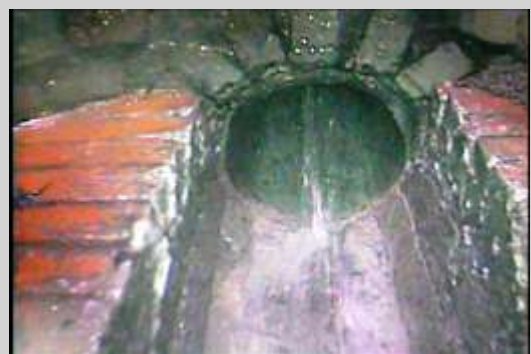
Drop In @ 6 O'Clock

Barrel deterioration and infiltration.
